TSB01082015

## TECHNICAL SERVICE BULLETIN

Models: Traditional BR Harvesters

**SUBJECT: Conveyor Motor Failure**

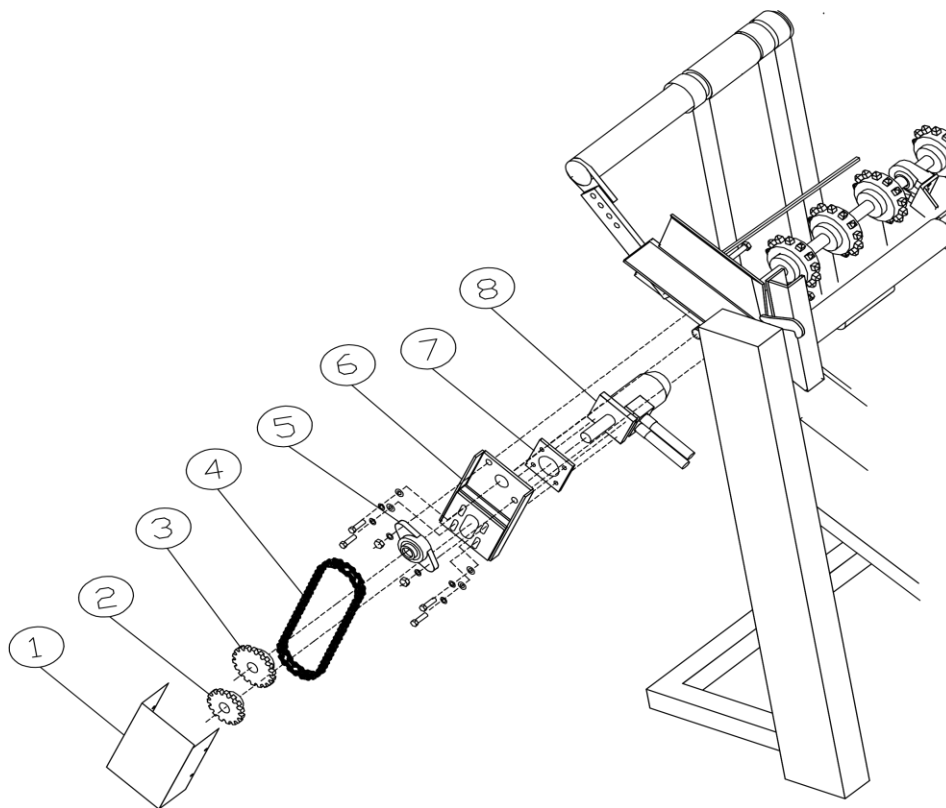
1. Shield
2. Drive sprocket
3. Driven sprocket
4. Roller chain
5. Flange bearing
6. Motor mount bracket

7. Motor spacer
8. Conveyor drive motor

When replacing the front or rear conveyor drive motor on a BR model harvester, be certain that the motor spacer (7) is correctly installed between the motor and motor mount bracket (6). See above drawing.

If the spacer is not located between the motor and mount bracket, the shaft-end cap on the motor will crack when the motor mounting fasteners are tightened.

If the motor end cap is cracked, the motor will leak a substantial amount of hydraulic fluid. The leakage generally appears to be leaking from the motor shaft seal.

It is important to note that the motor spacer may remain on the hydraulic motor when the motor is removed from the mount bracket. **Do not discard the spacer.**

When installing the motor, tighten the motor fasteners in a crossing pattern, in several steps, to 25-30 ft.-lbs. (34-41 N.m).
