## TECHNICAL SERVICE BULLETIN

**Models: Traditional BR Harvesters**

**SUBJECT: Conveyor Motor Failure**

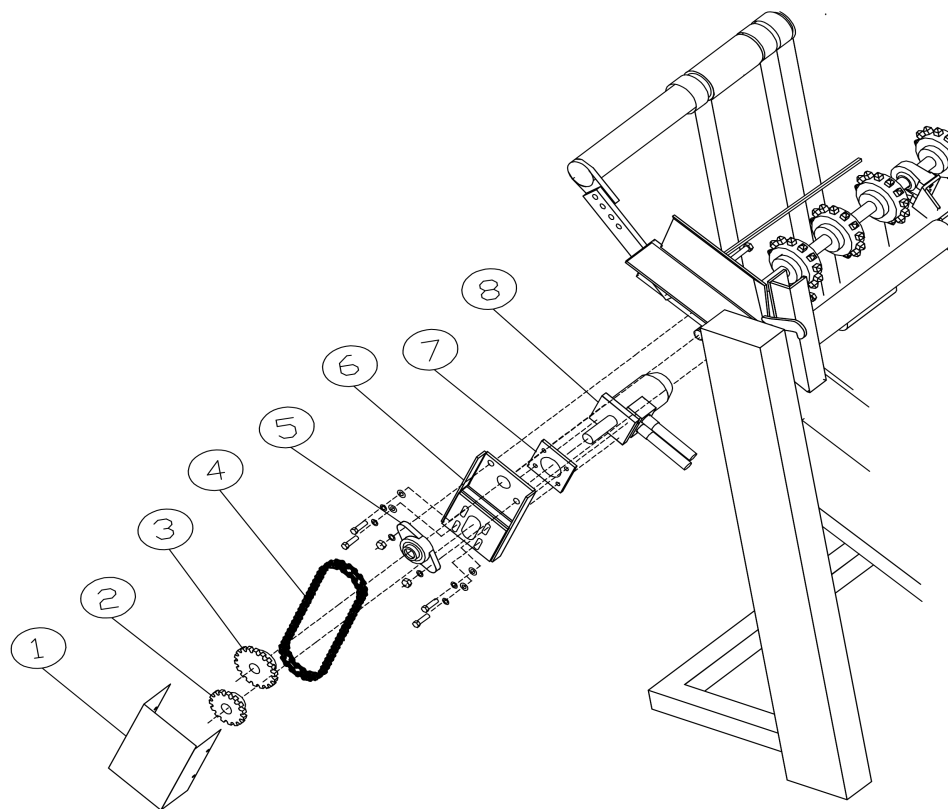
1. Shield
2. Drive sprocket
3. Driven sprocket
4. Roller chain
5. Flange bearing
6. Motor mount bracket
7. Motor spacer
8. Conveyor drive motor

If the spacer is not located between the motor and mount bracket, the shaft-end cap on the motor will crack when the motor mounting fasteners are tightened.

If the motor end cap is cracked, the motor will leak a substantial amount of hydraulic fluid. The leakage generally appears to be leaking from the motor shaft seal.

When replacing the front or rear conveyor drive motor on a BR model harvester, be certain that the motor spacer (7) is correctly installed between the motor and motor mount bracket (6). See above drawing.

It is important to note that the motor spacer may remain on the hydraulic motor when the motor is removed from the mount bracket. **Do not discard the spacer.**

When installing the motor, tighten the motor fasteners in a crossing pattern, in several steps, to 25-30 ft.-lbs. (34-41 N.m).
