TSB090908-011

TECHNICAL SERVICE BULLETIN

SUBJECT: CONVEYOR BELT REINFORCING CLIPS

AFFECTED MODELS: SR, SRA AND AR SERIES HARVESTERS

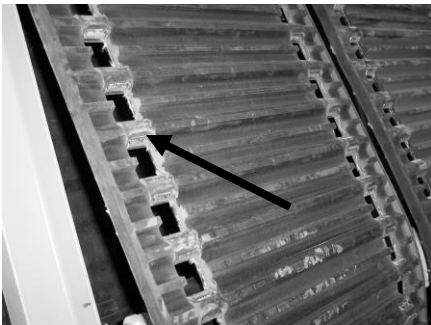
The sprocket lugs on the rubber belts are reinforced with metal clips. Belt and sprocket damage will occur if any of the clips are excessively worn, damaged or missing. To prevent damage to the rubber belts and sprockets make sure that all of the clips are securely installed and in acceptable condition.

Periodically inspect the rubber belts on the rear conveyor. Worn clips are best seen looking at the underside of the belt. Replace any clips that are excessively worn, damaged or missing. **Call Bucyrus Equipment Company (800-330-0857) for replacement clips and installation tool.**

- Clips—part No. 04-149-01
- Installation tool—part No. TCI900
